### Major Refinery

#### Digitized Facility™, As-Built Documentation

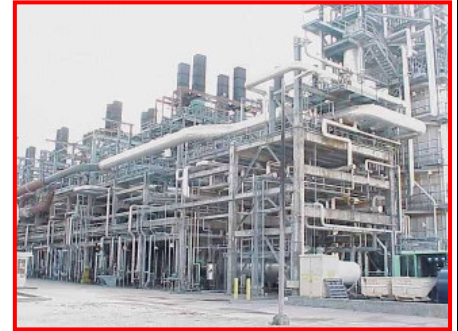
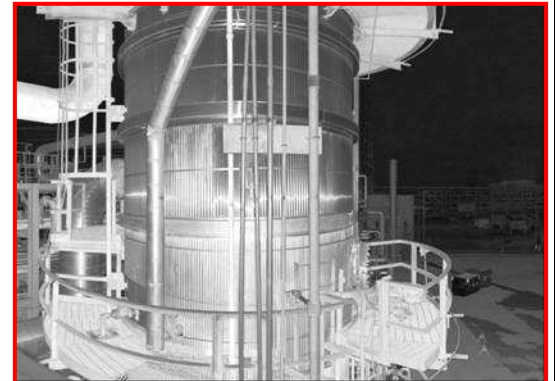
*Quantapoint Laser Image (Not a Picture)  
Each Point is a Measurement*

Quantapoint used laser scanning to “digitize” version the existing distillation column. The resulting Digitized Facility™ included photo-realistic and panoramic Laser Images™ of individual laser scans and high-definition and detailed Laser Models™ that integrated all of the laser data.

Quantapoint created sections using the Digitized Facility to locate the nozzle and clip orientations and elevations. The engineering contractor used this information to fabricate the new column. Quantapoint as-built specialists then completed the nozzle and clip orientation/elevation drawing using AutoCAD.
